## **Wetland Delineation Inventory, Functional Analysis and Impact Assessment**

East Industrial Road, Leetes Island Road, and East Main Street  
Branford, Connecticut

Costco Wholesale Corporation

September 9, 2015

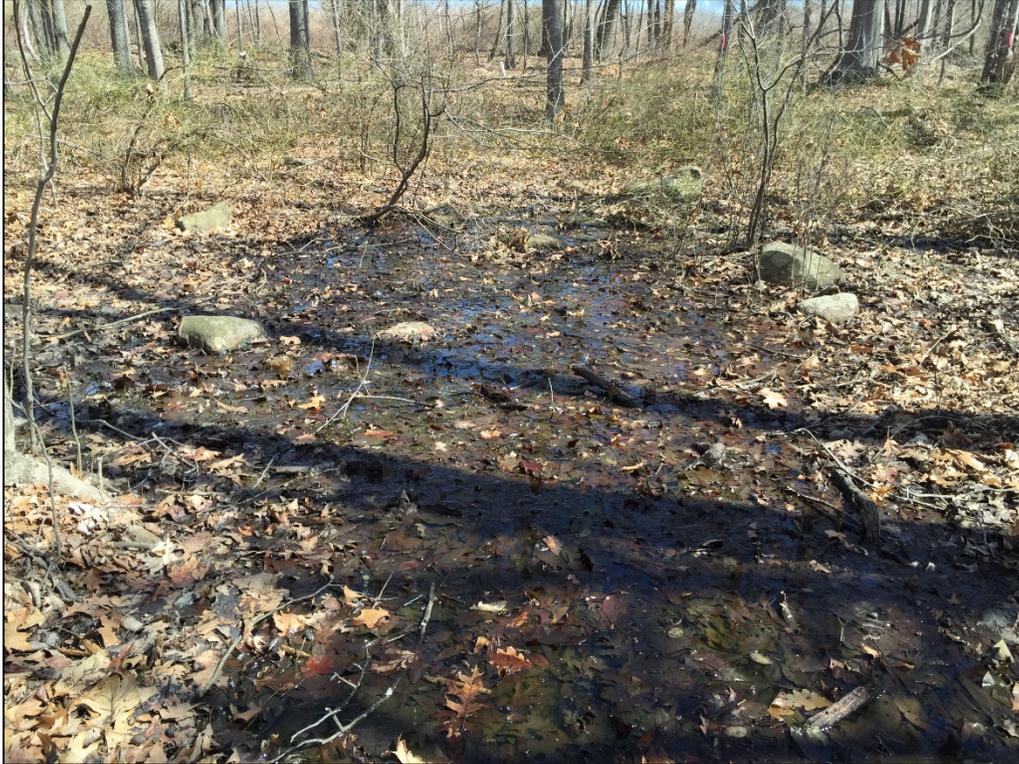
Photo 7: Wetland 2 in early spring prior to leaf-out, looking west.

Wetland 2 is a ±0.39 acre wooded swamp with a saturated to seasonally flooded hydrology. The wetland is situated on gently sloping terrace just north of, and bordering, the cut slope described above. The majority of the wetland maintained a saturated hydrology throughout the spring. Two small, separated depressions held standing water throughout the spring and would be classified as having a seasonally-flooded hydrology.

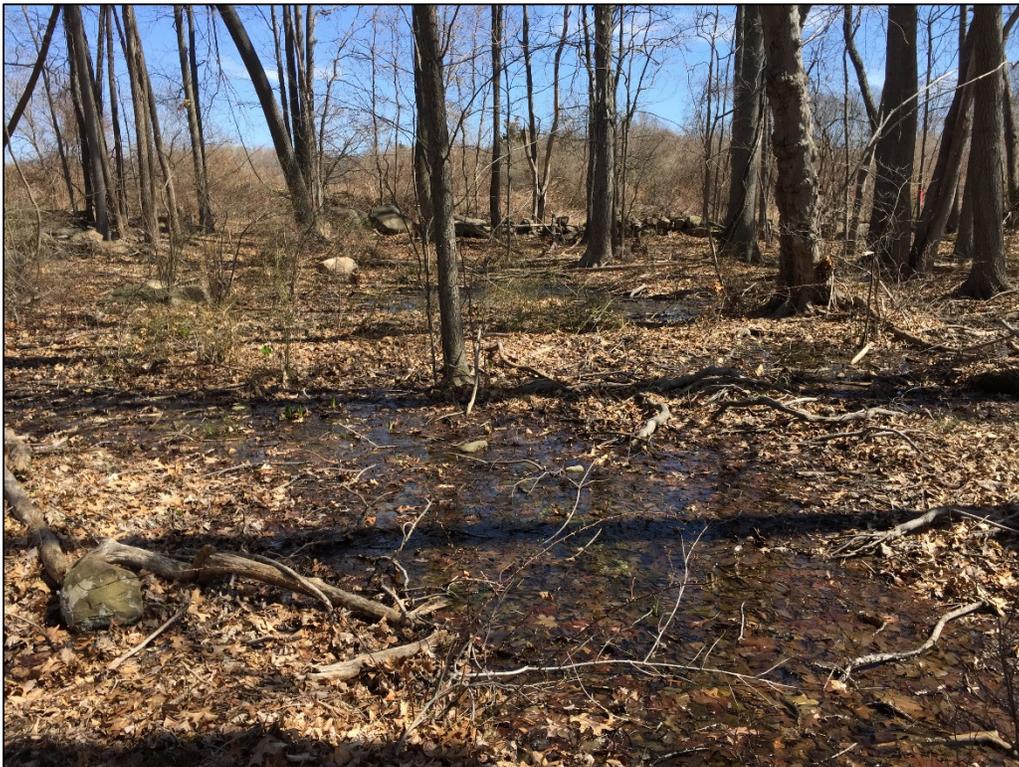
Photo 8: Wetland 2 in early spring prior to leaf-out, looking east.

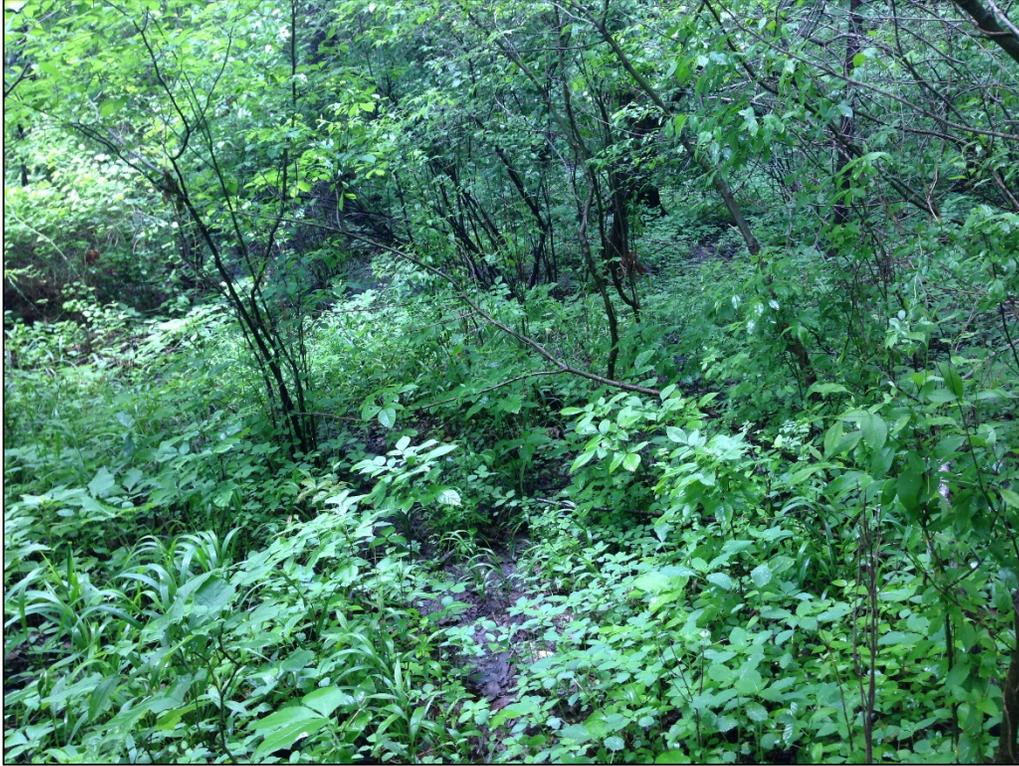
Photo 13: northeast portion of Wetland 1 showing dense ground and shrub cover vegetation.

Wetland 1 is the largest wetland at the site ( $\pm 3.83$  acres). It bisects the site in a north-south direction in the eastern portion of the site. The wetland is hydrologically connected to an offsite pond on the north side of Route 1 via a culvert, and discharges off-site to the south via a closed drainage system. Two man-made ponds are embedded within Wetland 1. The larger pond (Pond A) has a forested edge from the adjacent upland slopes. Scattered shrubs also grow along the shore including Silky Dogwood, Buttonbush (*Cephalanthus occidentalis*), and Multiflora Rose\* with Sensitive Fern. Within the pond there is a patch of Common Reed\* (*Phragmites australis*) and White Waterlily (*Nymphaea odorata*). Filamentous green algae are also present. The smaller pond (Pond B) is located a short distance east of Pond A. It has a dense edge of Silky Dogwood with Soft Rush (*Juncus effusus*) and Reed Canarygrass\* (*Phalaris arundinacea*). Patches of aquatic vegetation include waterweed (*Elodea spp.*) and smartweed (*Polygonum spp.*).

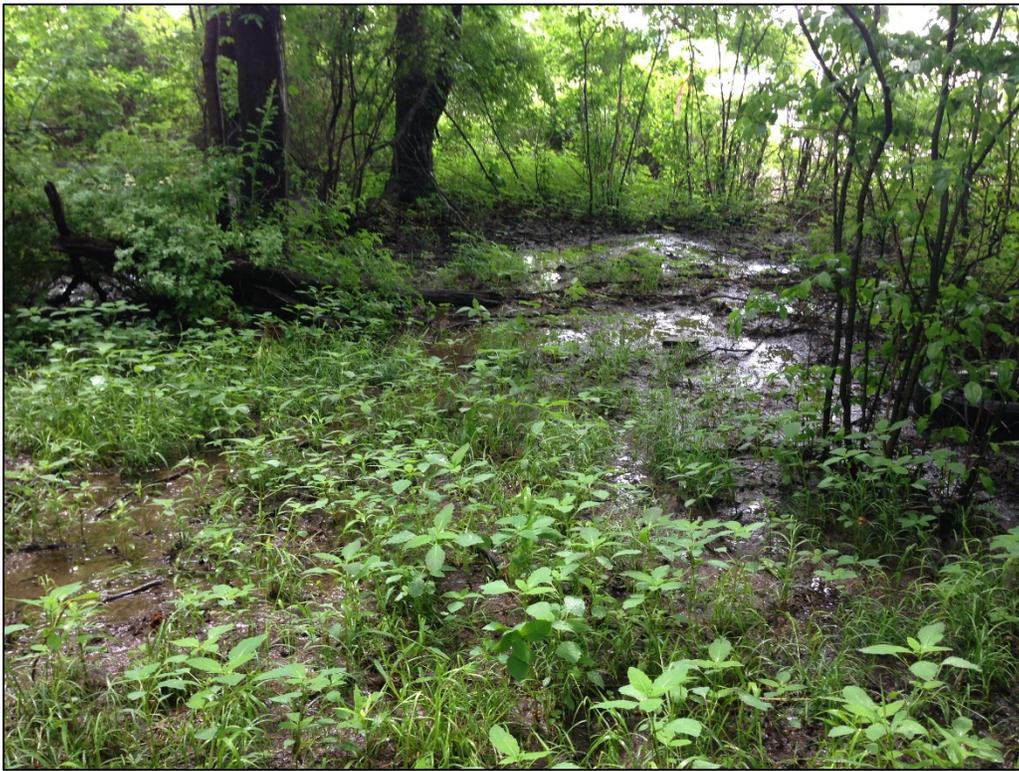
Photo 14: Southeast corner of Wetland 1.

The southern portions of Wetland 1 located below the cut slope are highly disturbed, and may be entirely anthropogenic in nature, having been created either as a result of the deep excavation of the slope that intercepted the water table, or from drainage that has been conveyed to it from other areas in closed or open systems.

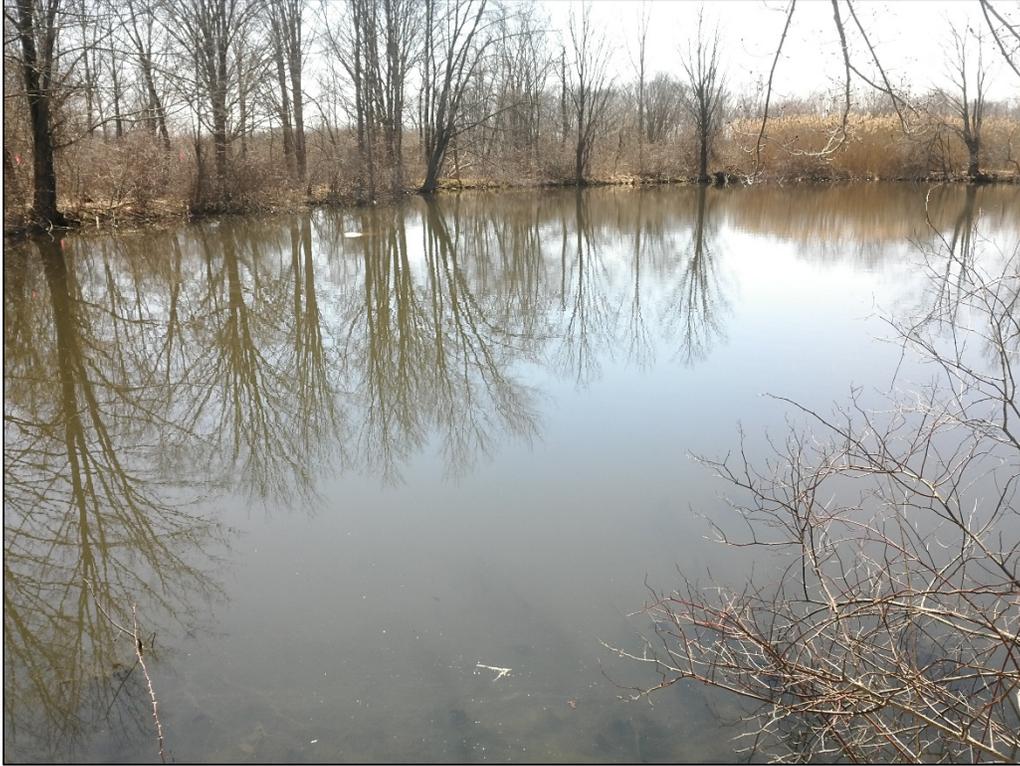
Photo 15: Pond A in early spring.

The site contains four ponds designated Ponds A, B, C and D (see Figure 2). Ponds A and B are embedded within Wetland 1 in the northeast corner of the Site and are connected by a culvert. Pond C is located offsite (north of Route 1) and is periodically connected to Pond A (and potentially Pond B) via the stormwater drainage system in East Main Street. Pond D (a.k.a. Wetland 4) is a steep-sided groundwater pond that discharges to the drainage system on the adjacent Stop & Shop development. All four ponds are anthropogenic in origin. Based on review of historic aerial photographs (see Appendix 2) we were able to ascertain the approximate age of these ponds. Pond C is the oldest, having been created prior to 1934. Ponds A and B were created sometime between 1951 and 1965. Pond D was constructed between 1971 and 1986.

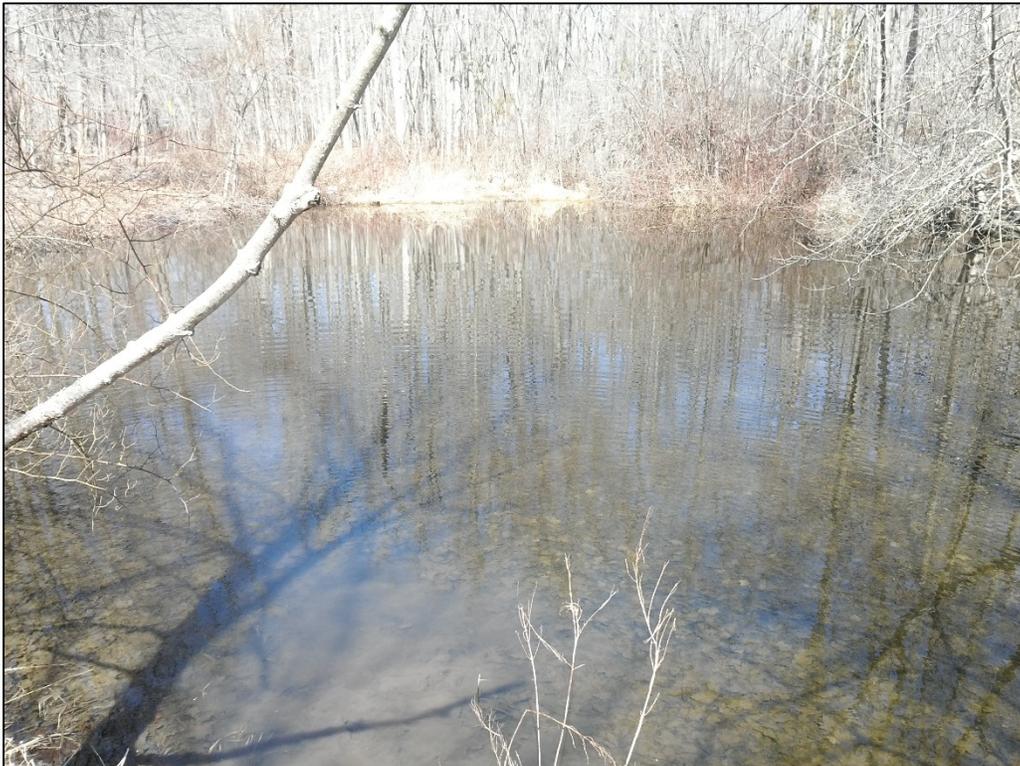
Photo 16: Pond B in early spring.

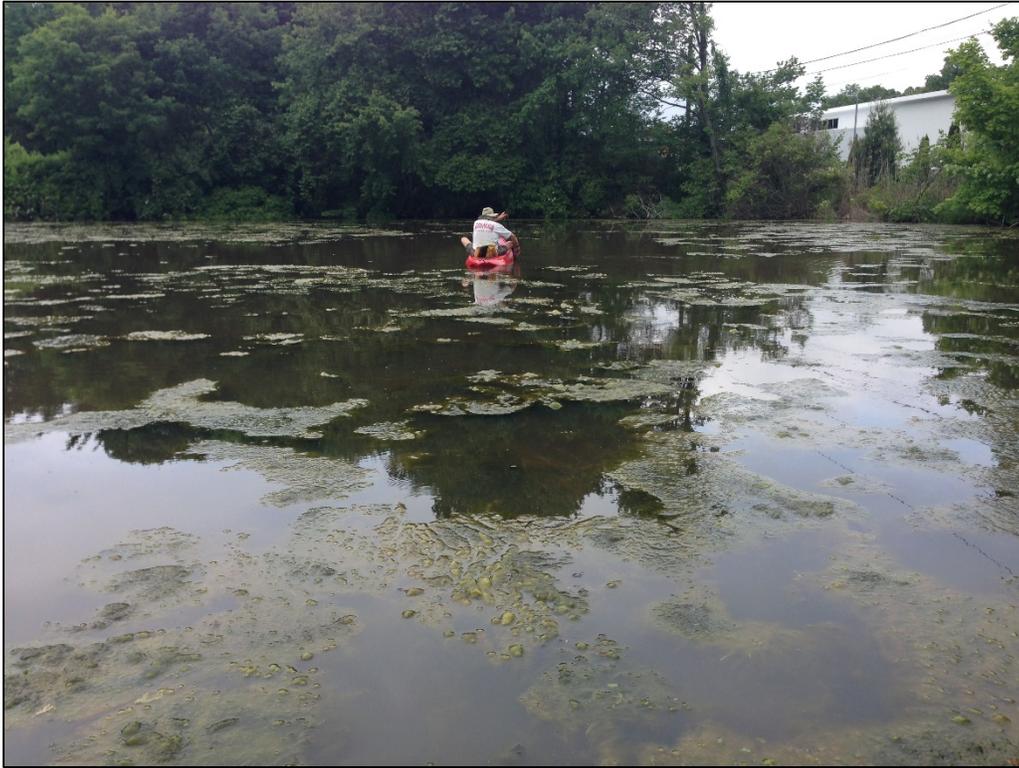
Photo 17: Pond C looking north.

Pond C is located north of Route 1. The Pond is shallow and the shore is partially wooded with Red Maple, Sugar Maple, Green Ash, Black Willow, and American Elm. The shrub layer varies from open to dense thickets and consists mostly of Arrowwood Viburnum, Silky Dogwood, Multiflora Rose\*, and Buttonbush. Minimal aquatic vegetation was observed and was mostly Duckweed (*Lemna minor*) and watermeal (*Wolffia sp.*). On the east side of the pond there is a water quality swale which is vegetated mostly with Common Reed\*. The vine layer includes Virginia Creeper and Asiatic Bittersweet\*.

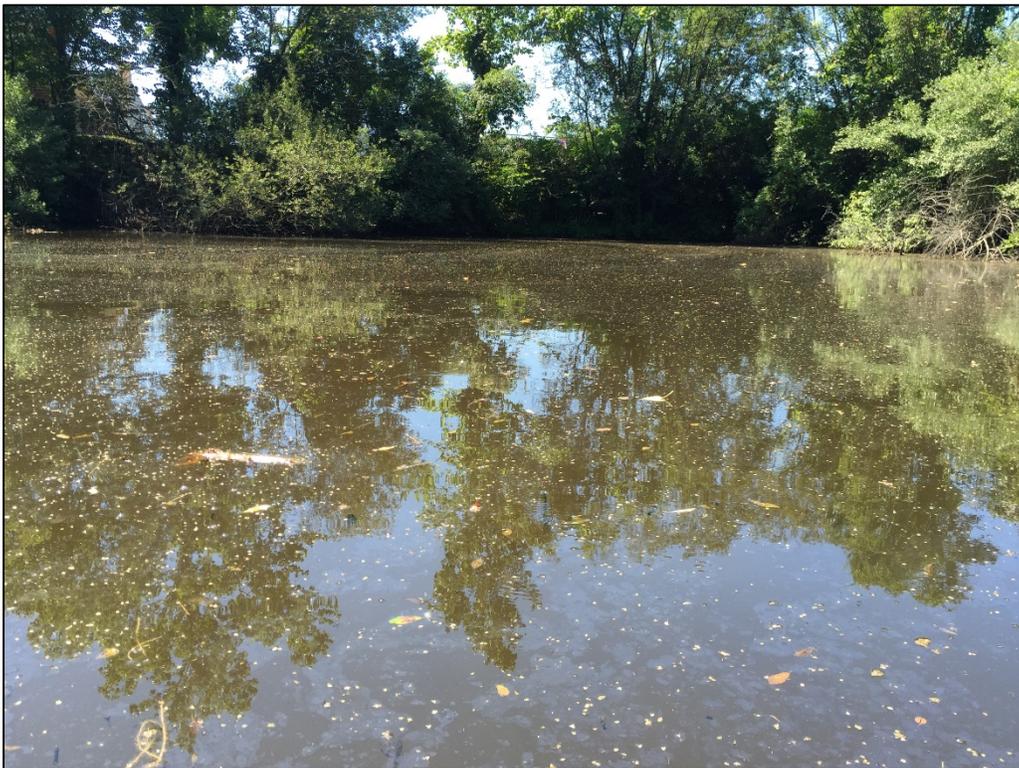
Photo 18: Pond D (Wetland 4) looking south towards Stop & Shop Supermarket.

Wetland 4 is a ±0.26 acre excavation that intercepts to the water table. It discharges to the stormwater management system of the commercial development at the corner of Leetes Island Road and East Industrial Road. The steep-sided basin is ponded and the water level fluctuates in response to seasonal and storm events. There is a narrow band of with wooded swamp vegetation growing along the shore, consisting primarily of Red Maple, Common Cottonwood (*Populus deltoides*), Pussy Willow (*Salix discolor*), and Multiflora Rose\* (*Rosa multiflora*).

Pond D had an abundance of trash and floatables (e.g., plastic shopping bags) consistent with a stormwater treatment pond. Water depth was greater than four feet. The pond substrate was

mucky (organic) over stone. Vertical visibility was approximately two feet. Odonates (dragonflies and damselflies) were observed, along with floating feathers indicative of waterfowl stopover habitat.

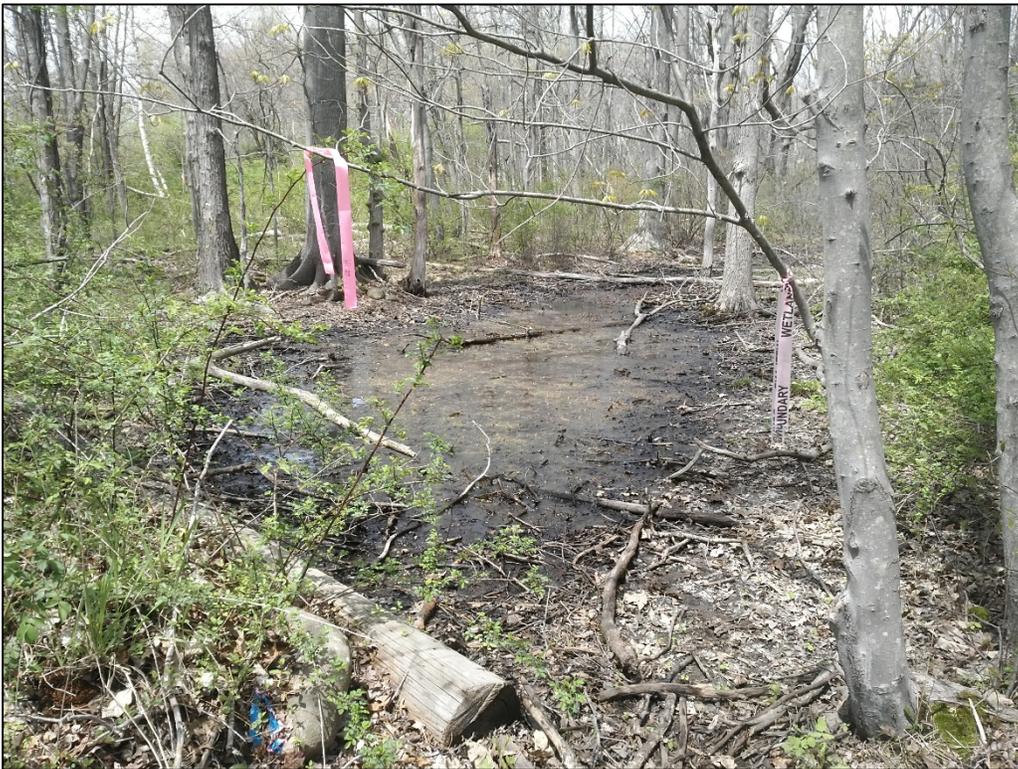
Photo 20: Area of Wetland 1 where wood frog were observed breeding in 2014.

Wetland areas with seasonally flooded and permanently flooded hydrology were surveyed for amphibians from April to June of 2014 and 2015. Survey methods included visual searches for egg masses and adults, cover searching (i.e., turning rocks, logs and debris) for adults, auditory surveys for calling frogs and toads, and dip-netting for larval amphibians. One vernal pool indicator species, the wood frog (*Rana sylvatica*), was observed on the site in 2014. One (or possibly two) adults were heard calling and a single egg mass was found in the southeast corner of Wetland 1, in a flooded depression adjacent to flag #21. During the spring 2015

The presence of one or two wood frogs (and a single egg mass) is not unusual, as wood frogs are capable of migrating distances of 3000 feet (or more), and often seek out new breeding pools in which to colonize. Wetland 1 is located in the southeast corner of the Site, within the migratory distance of other potential breeding pools located within a large forest block east of the Site adjacent to Towner Swamp Road. It is likely that individuals observed on the Site in 2014 originated from this area. The lack of mating or breeding activity in 2015 suggests that there was no survivorship in 2014. A major factor precluding the presence of robust populations of vernal pool wildlife is the lack of mature forest cover on as well as immediately adjacent to the site, as vernal pool species utilize forested habitat during the non-breeding season. The presence of high-density development and high-traffic roads adjacent to the site also severely limit the ability of amphibians to move into and out of site wetlands during migration.

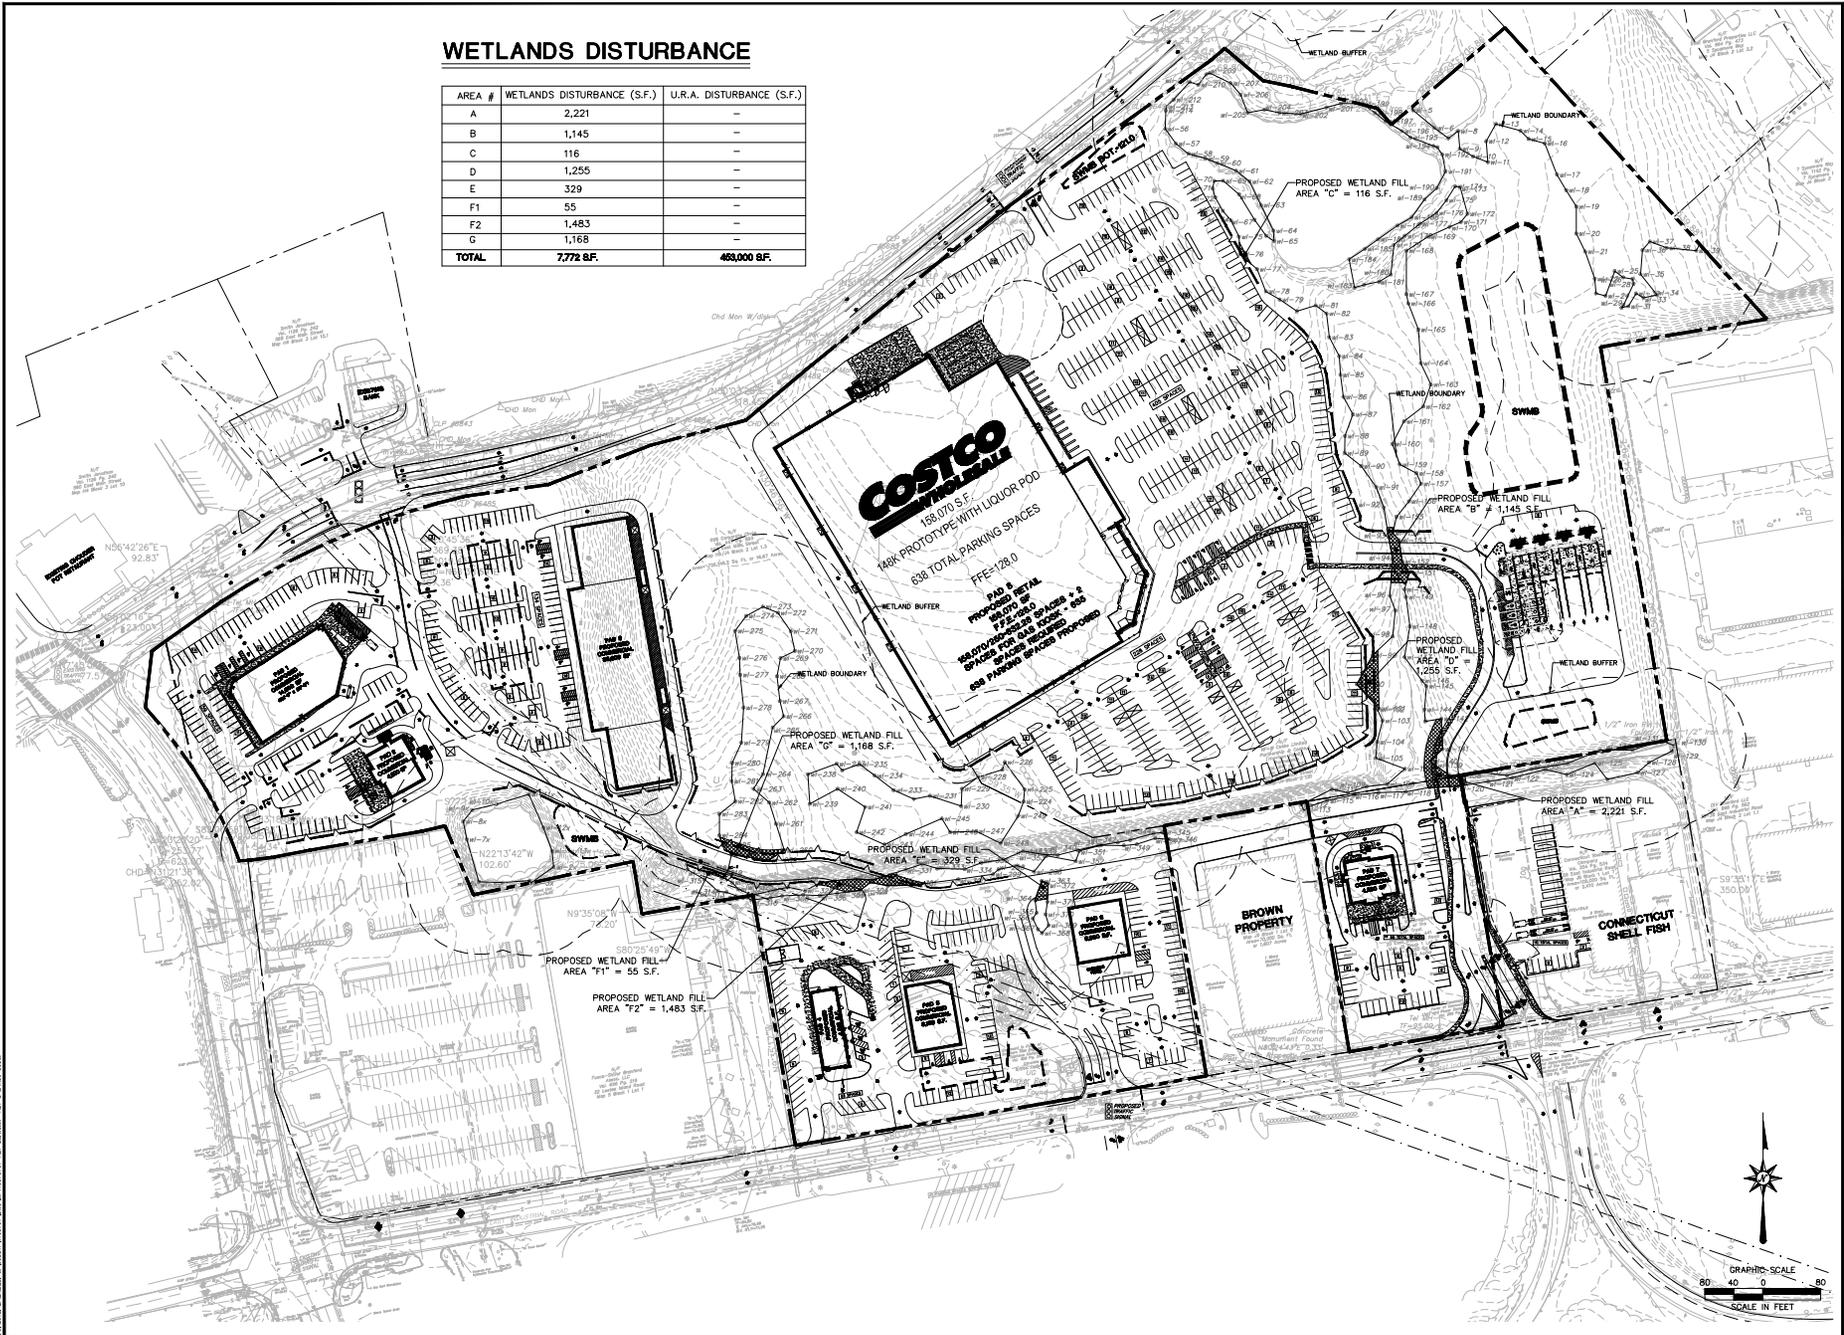
### WETLANDS DISTURBANCE

AREA #	WETLANDS DISTURBANCE (S.F.)	U.R.A. DISTURBANCE (S.F.)
A	2,221	--
B	1,145	--
C	116	--
D	1,255	--
E	329	--
F1	55	--
F2	1,483	--
G	1,168	--
<b>TOTAL</b>	<b>7,772 8F.</b>	<b>483,000 8F.</b>

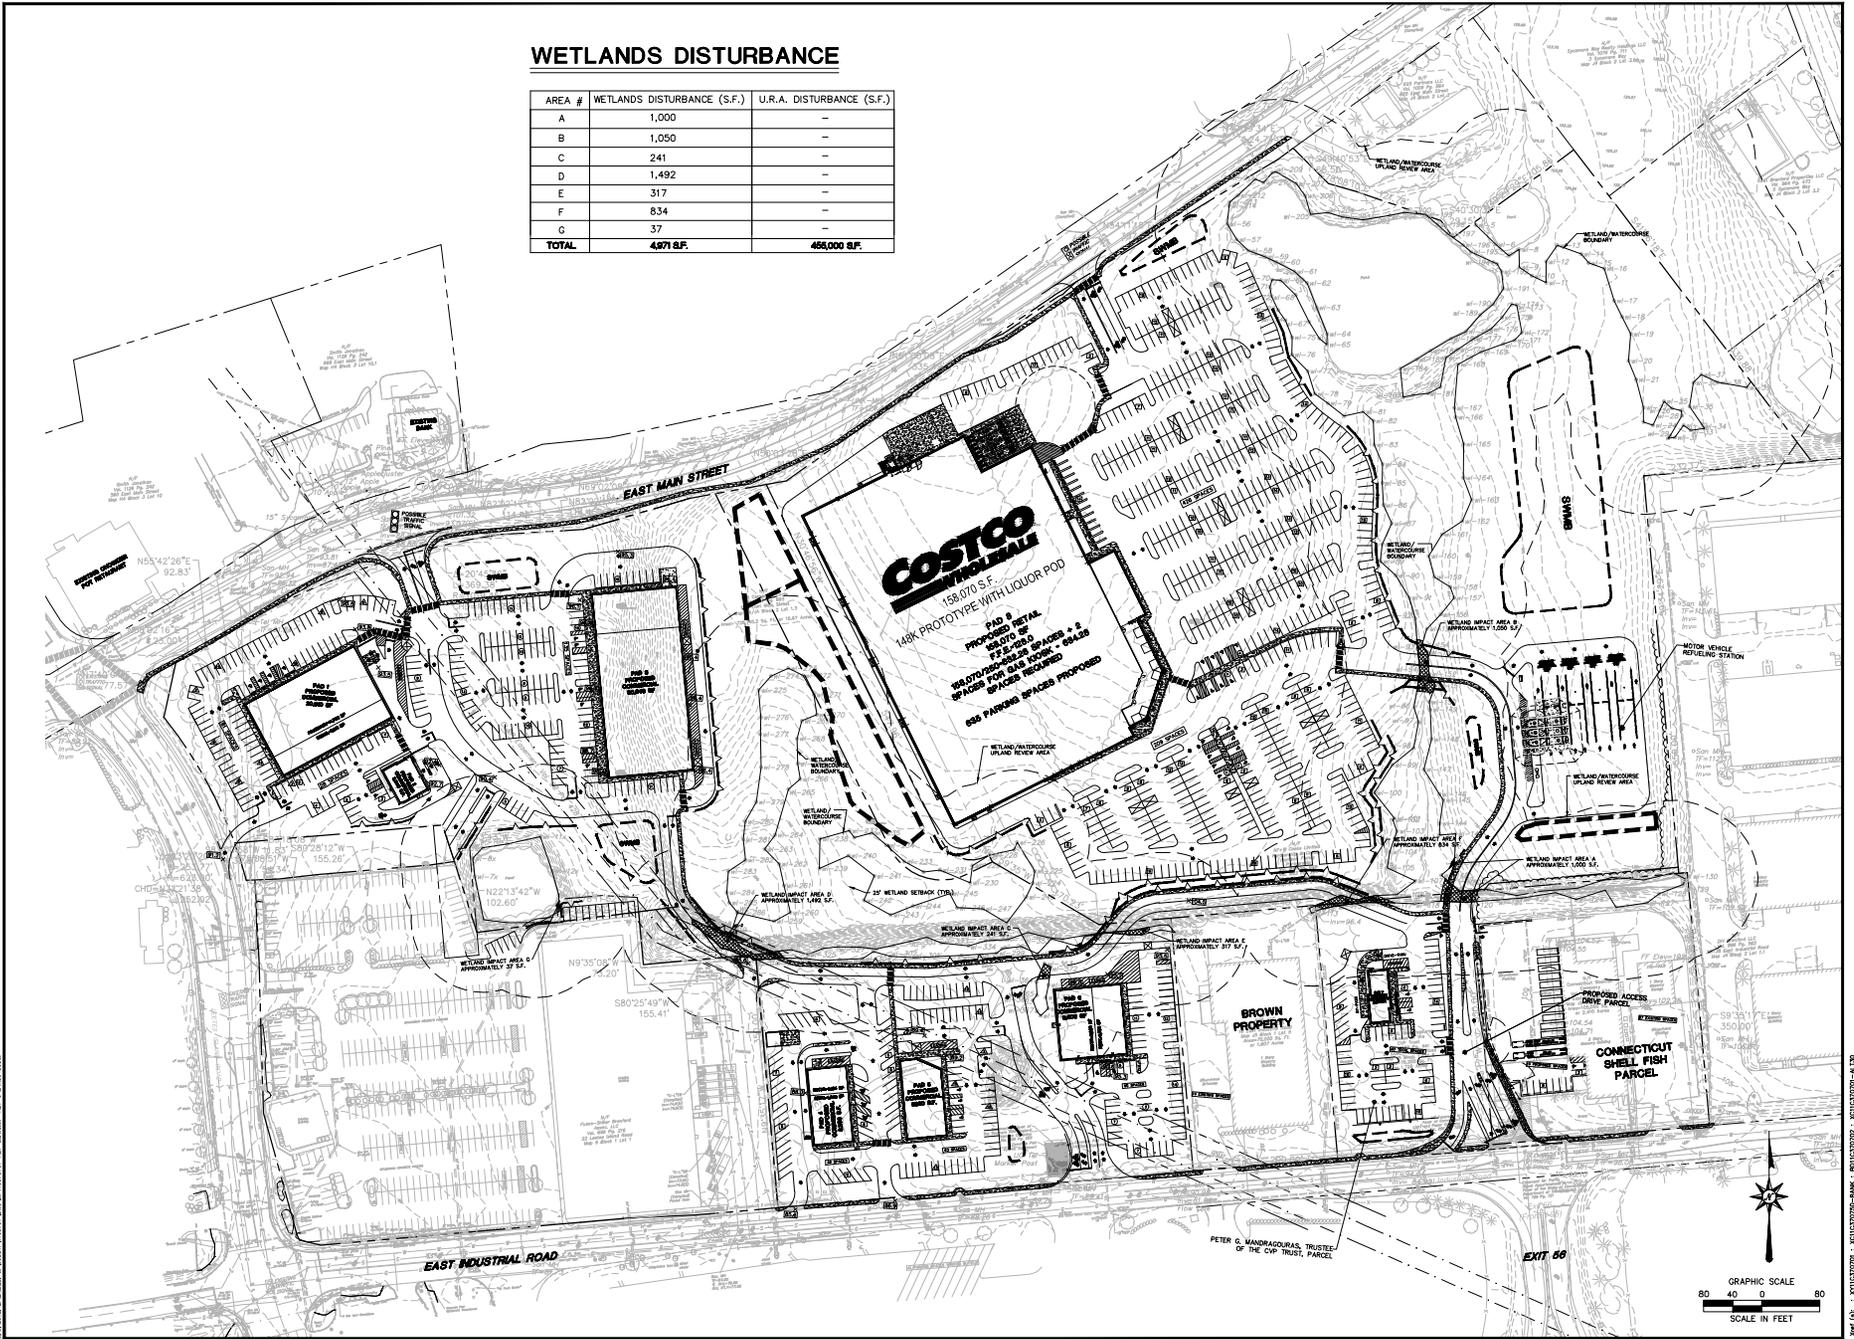
### WETLANDS DISTURBANCE

AREA #	WETLANDS DISTURBANCE (S.F.)	U.R.A. DISTURBANCE (S.F.)
A	1,000	-
B	1,050	-
C	241	-
D	1,492	-
E	317	-
F	834	-
G	37	-
<b>TOTAL</b>	<b>4,671 S.F.</b>	<b>458,000 S.F.</b>
