2025 James Blackstone Memorial Library Building and Grounds Projects

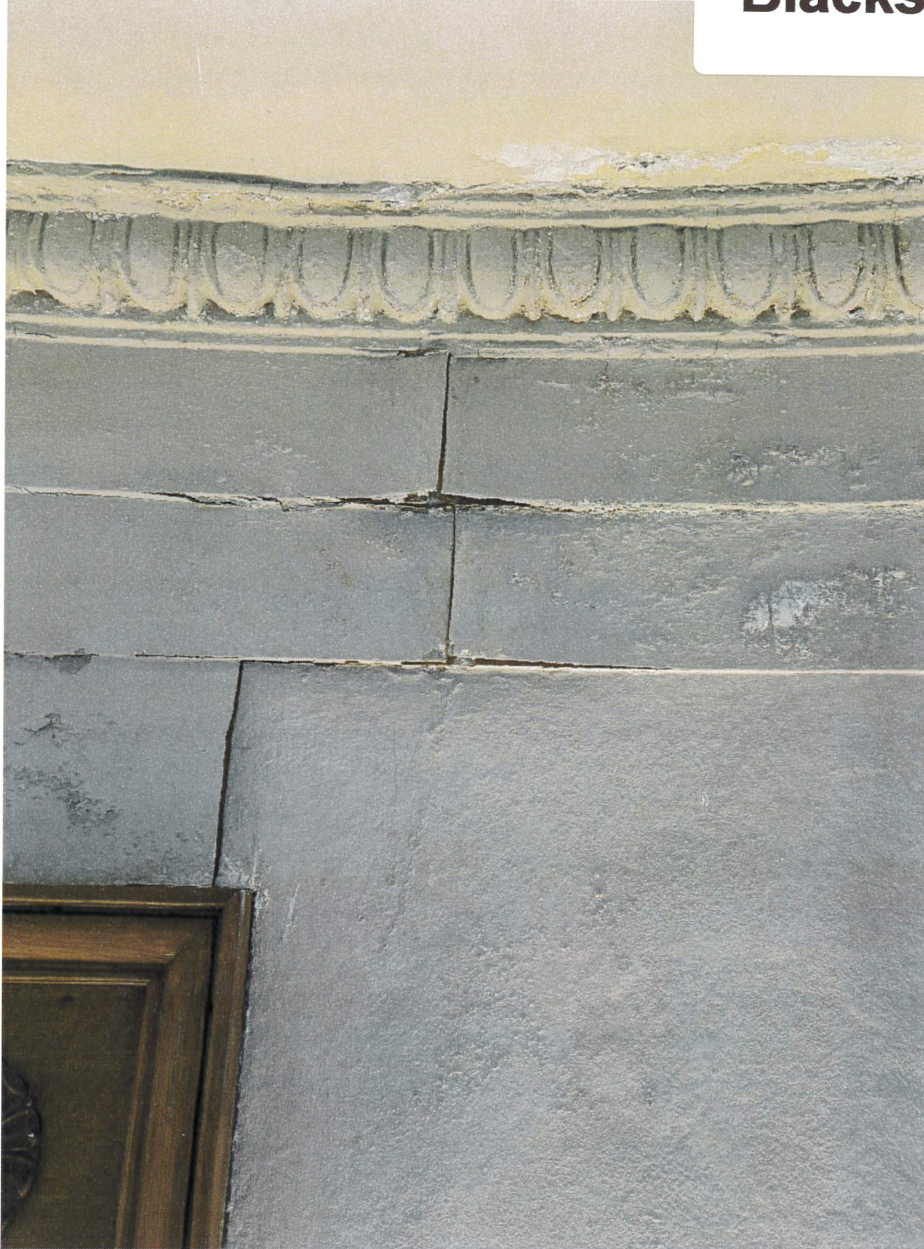
Item #12D
Blackstone Library

Plaster crumbling, First Floor mezzanine wall/ceiling around curved section

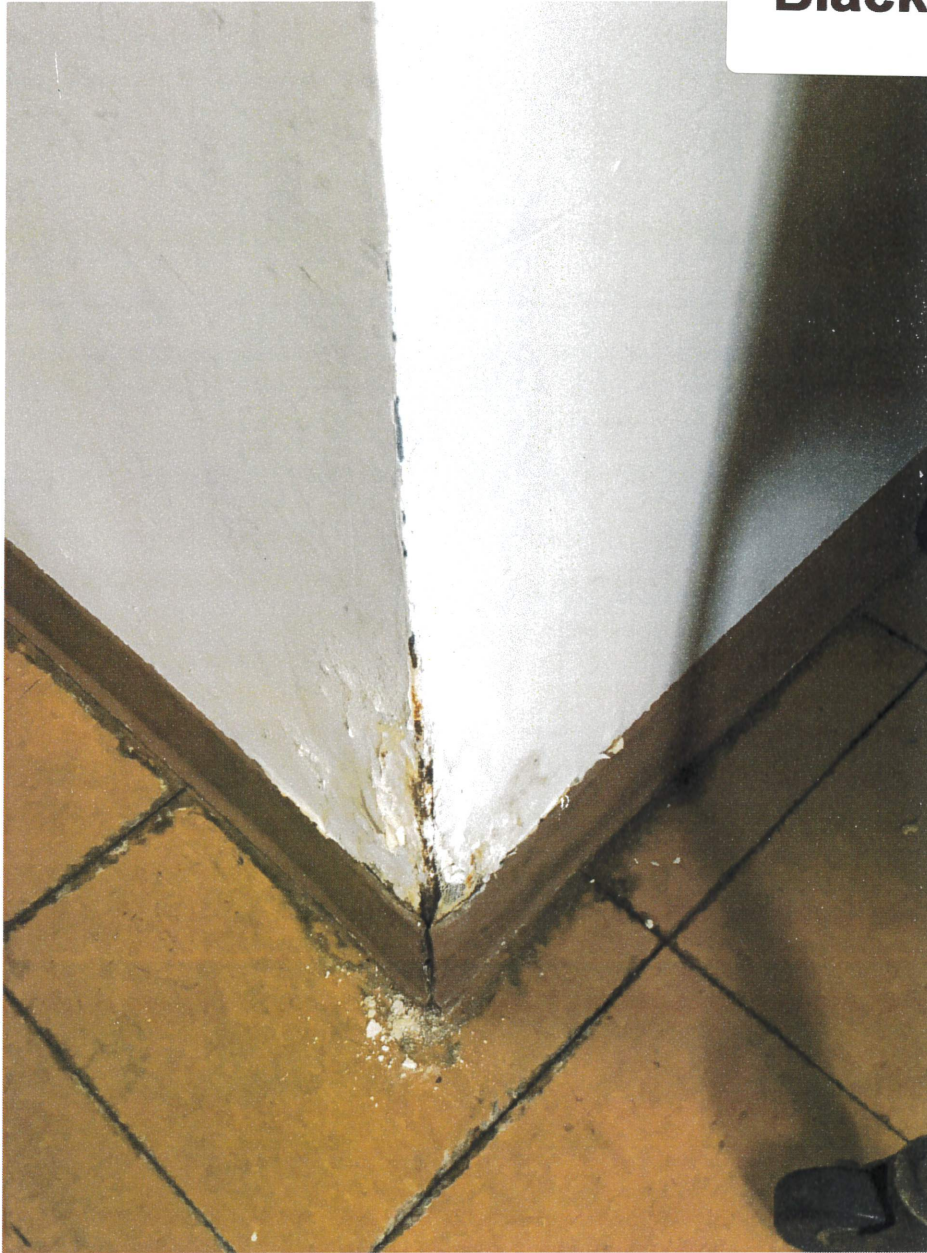
Item #12D
Blackstone Library

Leak from ground floor water closet (repair in progress); tile floor may need abatement

There is a lot of control equipment in the Staff Area Entrance. This equipment is near a water closet that has been leaking and causing rusting, wall deterioration and mold. Additionally, the open Book Drop that is located in this area represents a fire hazard. This area needs to be reworked to make it dry, safe and secure. [The floor tiles in this area are deteriorating and could require asbestos abatement.]

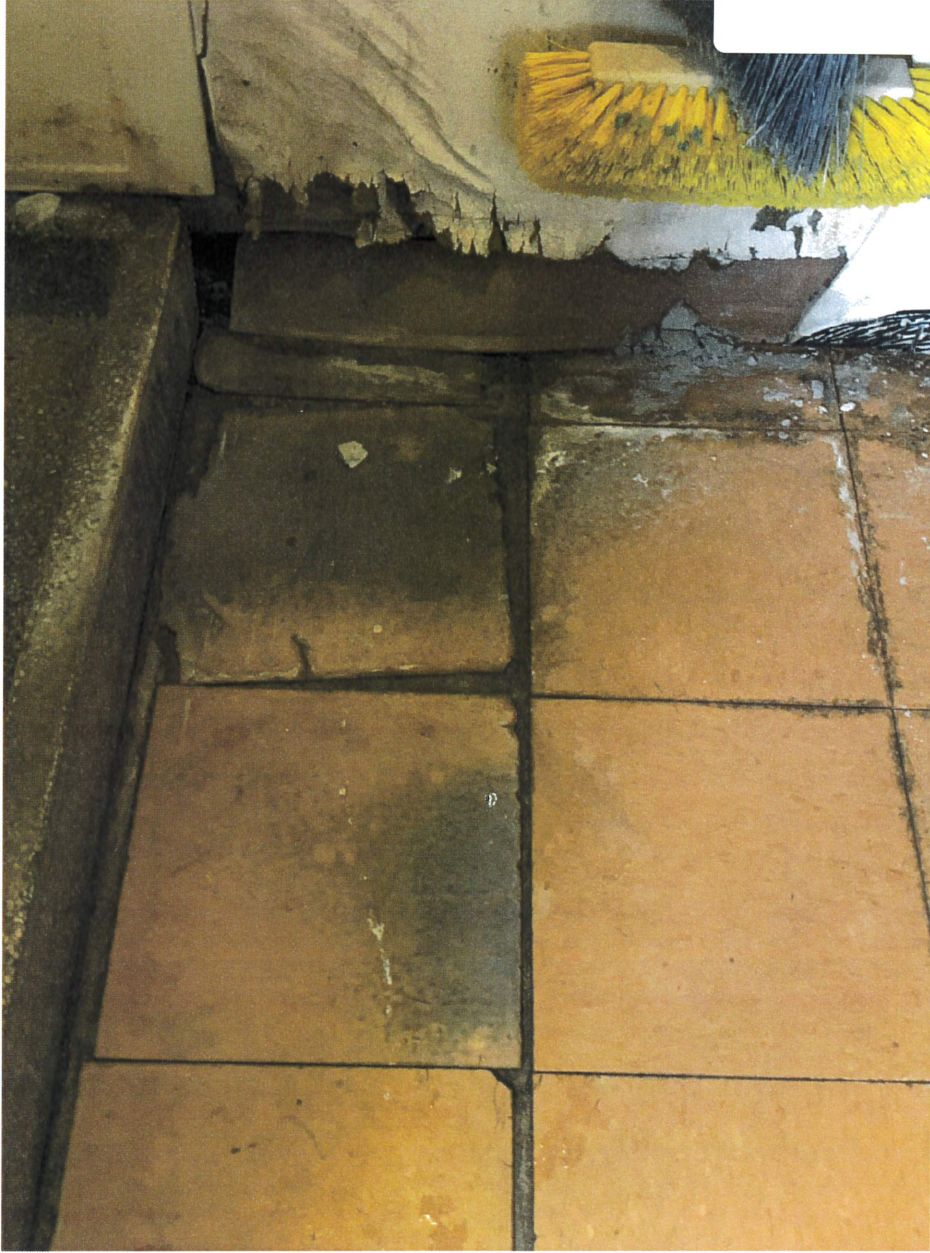
Item #12D
Blackstone Library

Leak from ground floor water closet (repair in progress); tile floor may need abatement
